# Ice Force and Scour Instrumentation for the White River, Vermont

# Special Report 96-6

Cold Regions Research &  
Engineering Laboratory

Prepared for  
STATE OF VERMONT  
and  
FEDERAL HIGHWAY ADMINISTRATION

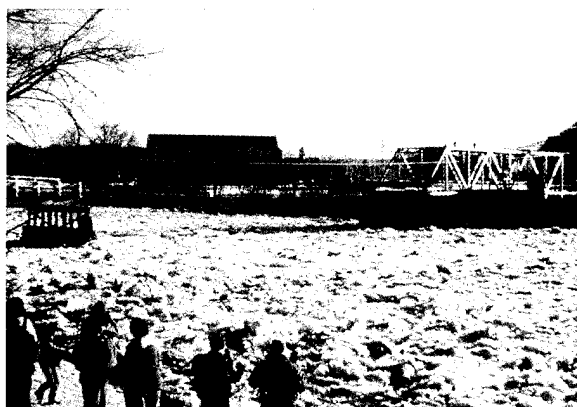
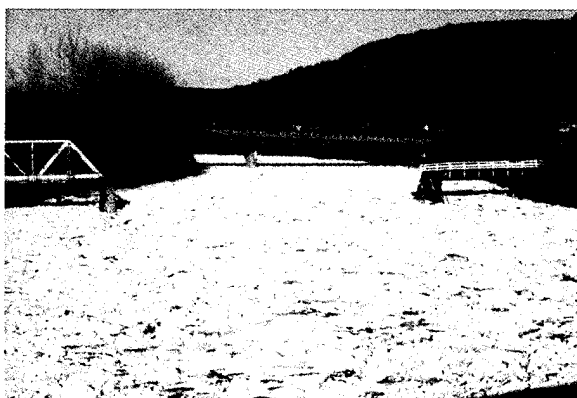
*a. Looking downstream.*

*b. Looking upstream. The Route 5 bridge is in the background.*

*Figure 3. Failure of the Bridge Street bridge, January 26, 1990.*

This temporary bridge lasted until January 26, 1990, when it collapsed during ice breakup. One pier collapsed first, dropping two spans into the river. Fifteen minutes later a second pier failed, dropping a third span into the river (Fig. 3). Historical flow and weather data (App. A) show that the bridge had been subjected to breakups with potentially more ice, due to lower temperatures or higher stage levels or both, than in previous

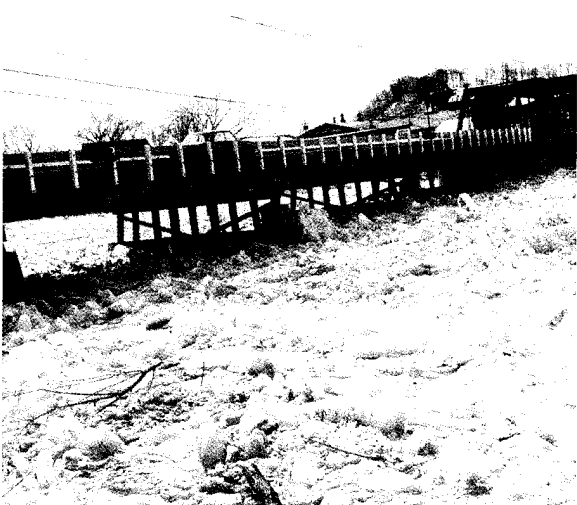
*Figure 4. Temporary piers subjected to ice forces in 1969.*

years (Fig. 4). Then why should it have failed? The most likely cause is deterioration of the structural integrity of the foundation due to the cumulative effect of scour. Several post-failure observations indicate that scour around the Bridge Street piers was the primary cause of failure, aggravated by the ice. The local newspaper reported that the bridge "seemed more flexible" to local commuters on the day of the failure. Also heard were comments on how good the fishing was underneath the concrete piers. The concrete used to encase the piles was cast directly on the riverbed, without a cutoff wall or bed protection.

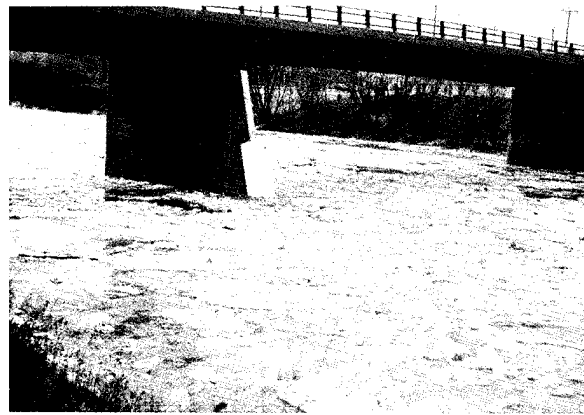
Figure 18. Ice conditions during breakup, March 10, 1992.

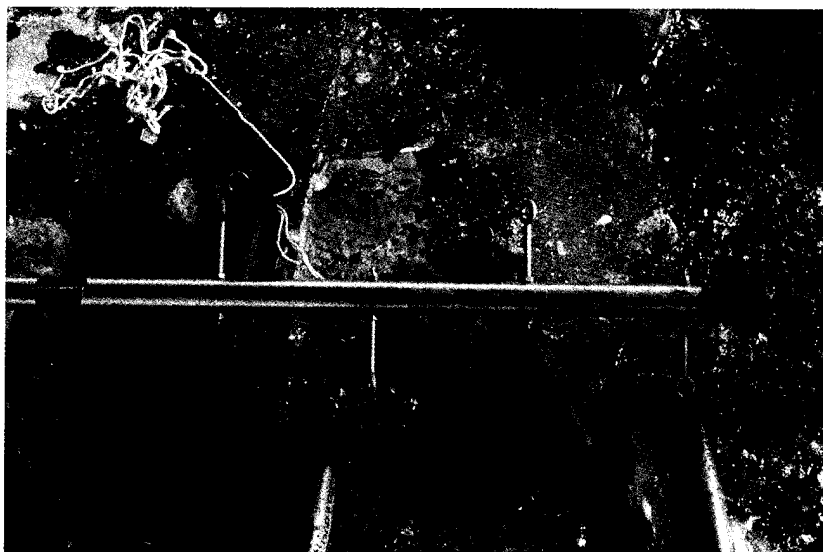
Figure 24. "Fish pole" with attached fish.
